# FENDER BANDMASTER REVERB TFL5005D RESTORATION

February 2025

Fender Bandmaster Reverb TFL5005D

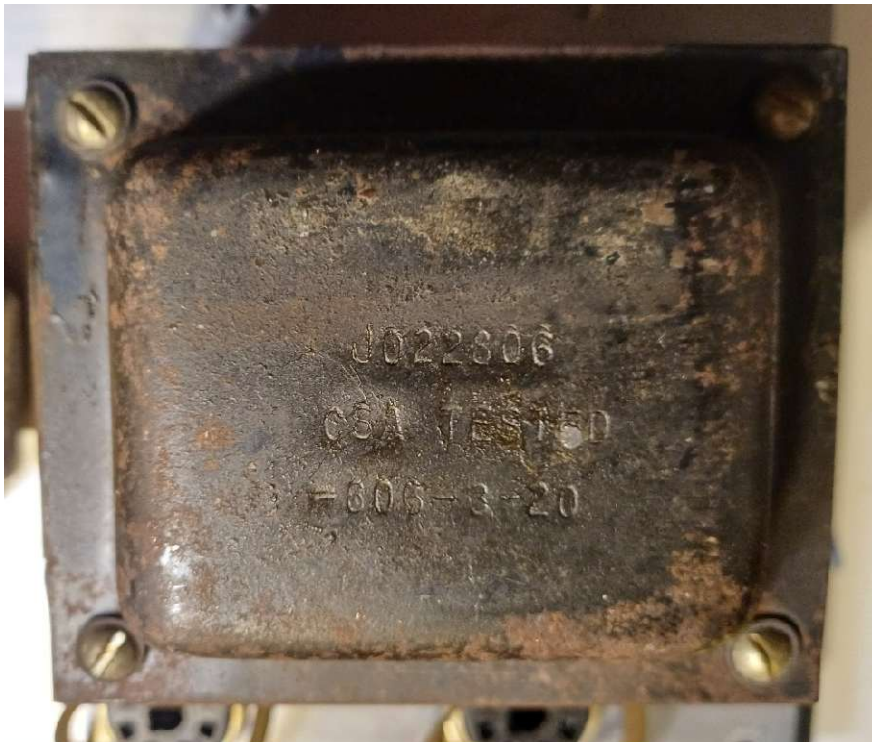
- Power transformer: Schumacher EIA 606 3-20 ⇒ 20<sup>th</sup> week of 1973.
- Output transformer: Schumacher EIA 606 1973 ⇒ 19<sup>th</sup> week of 1973
- Choke: Schumacher EIA 606 0173 ⇒ 1<sup>st</sup> week of 1973

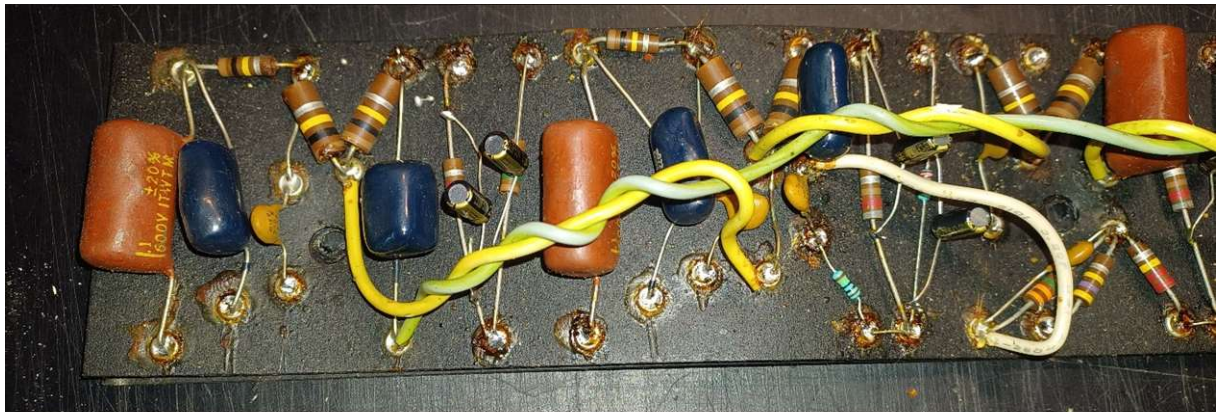
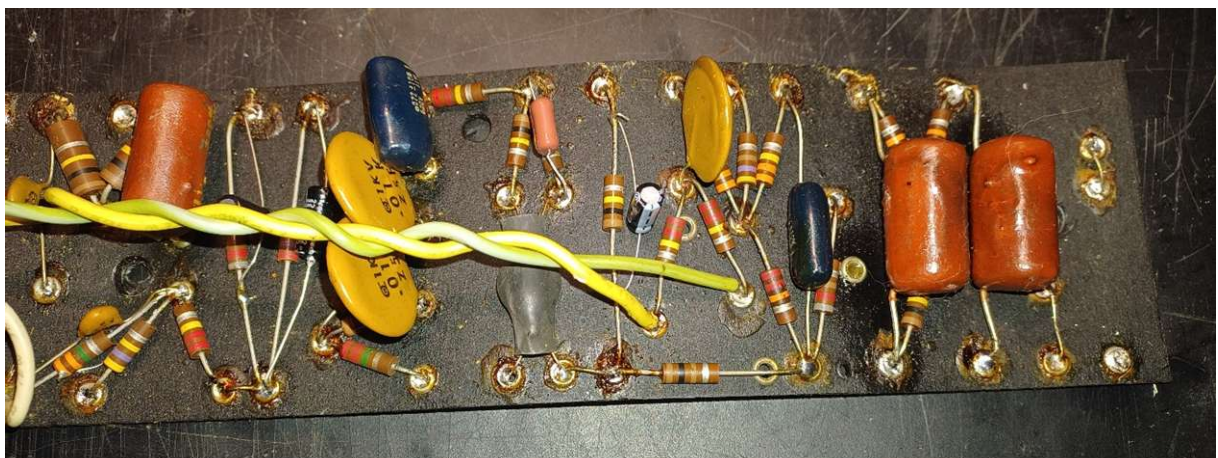
The board:

Now you can really see how dirty the board is...

I removed all components and wiring from the board carefully. I removed all solder from the eyelets. I then used a heat gun to heat up the board and backing board and soak up dirty wax and flux with a paper towel repetitively, and cleaned it all thoroughly with IPA.

I cleaned all the components with IPA, and used some mild heat to get the wax off the coupling caps.

All the resistors and capacitors checked out fine in terms of their values. I will replace the two metal film resistors with carbon film 1/2W, and the radial cathode decoupling caps with Vishay axial caps. Everything else can stay.

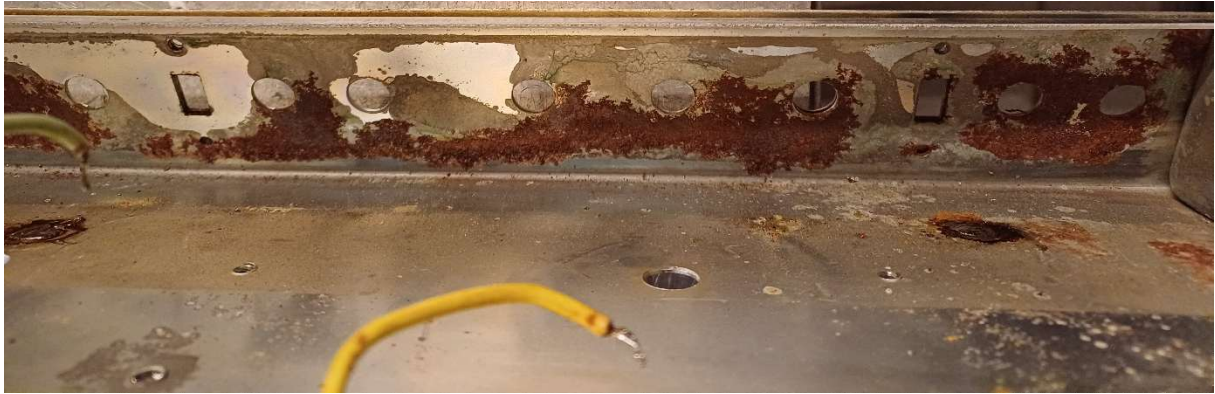
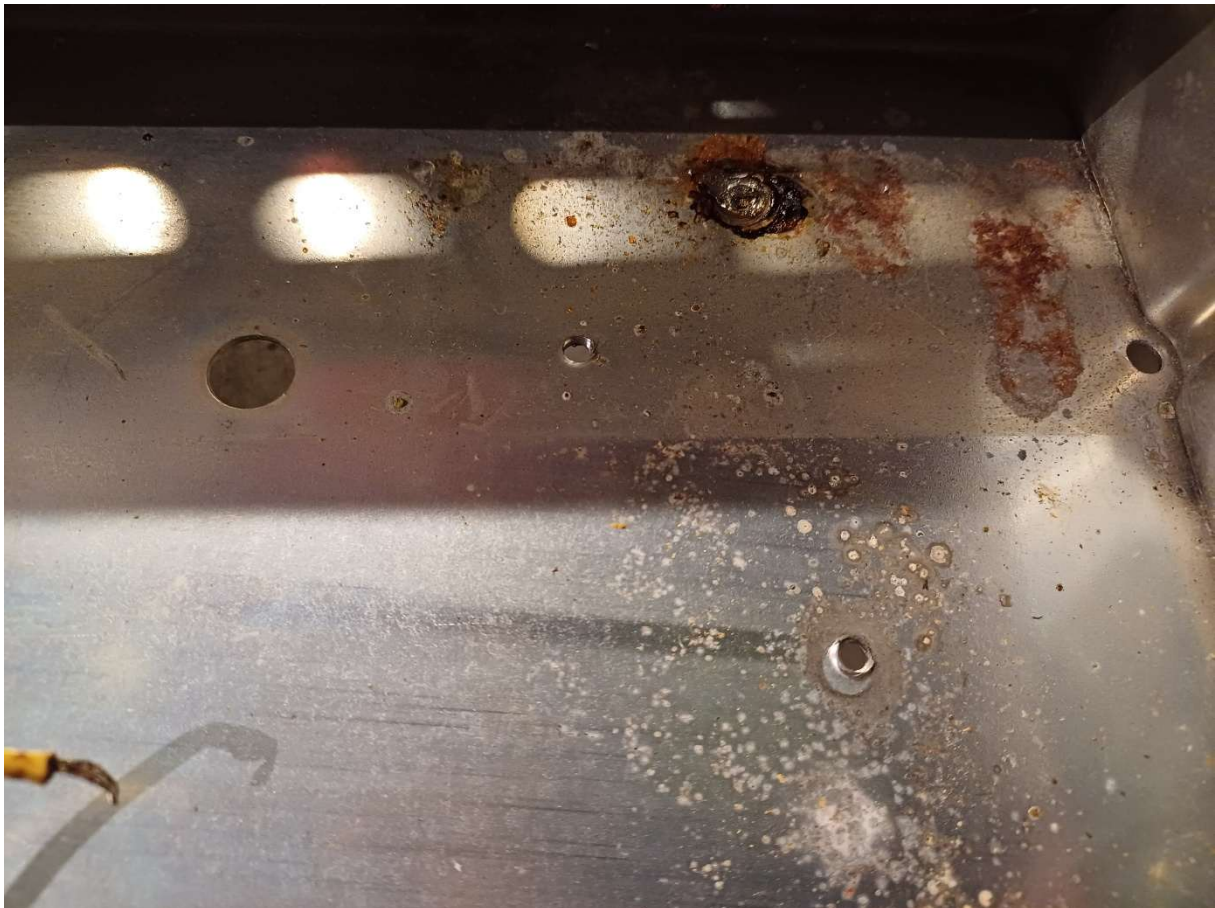
### The chassis:

See the amount of rust around the pots and input jack holes with the brass plate removed! I will have to remove the rust entirely and treat it with 'rust-stop', a chemical that reacts with the iron oxide and turns into an inert compound, so it will not rust any further.

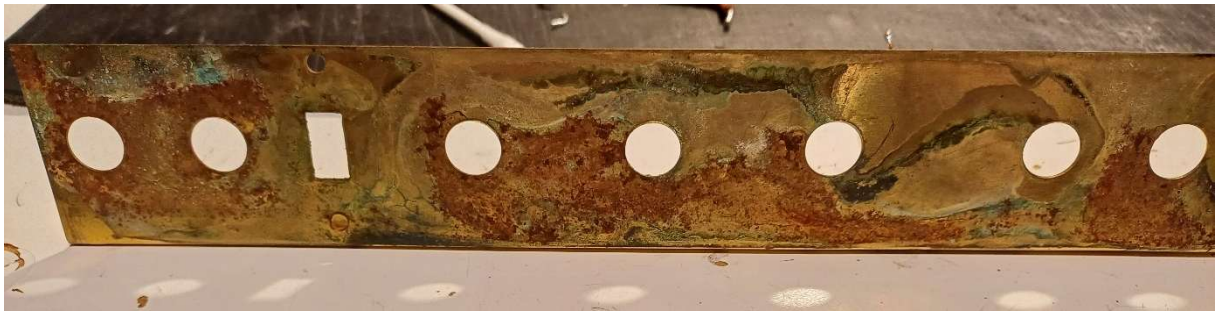
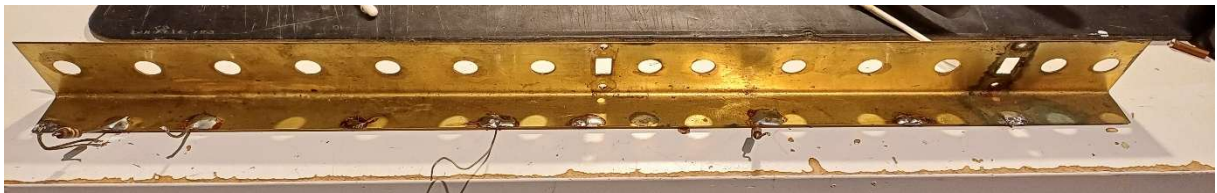
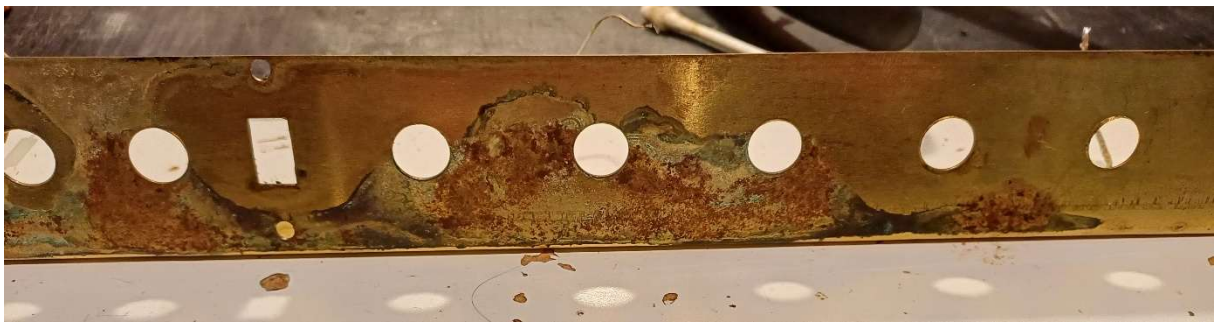
The brass plate and some serious oxidation:

The rust sits on the brass, but it has not corroded the plate itself. I rubbed it off with a non-metallic rubbing sponge and some naphtha. I then treated it with copper polish.

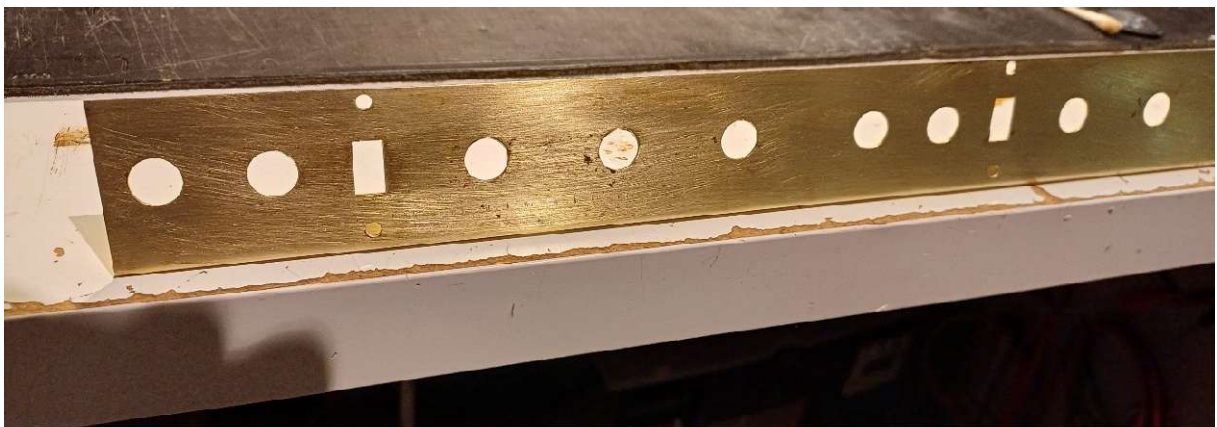
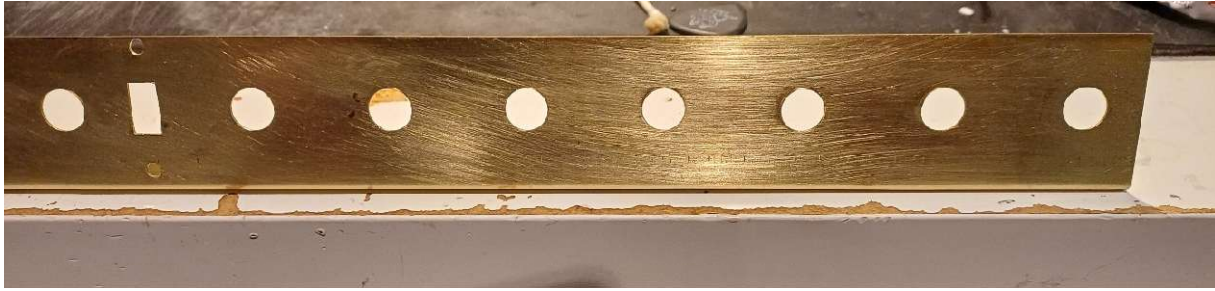
After cleaning it looks like this:

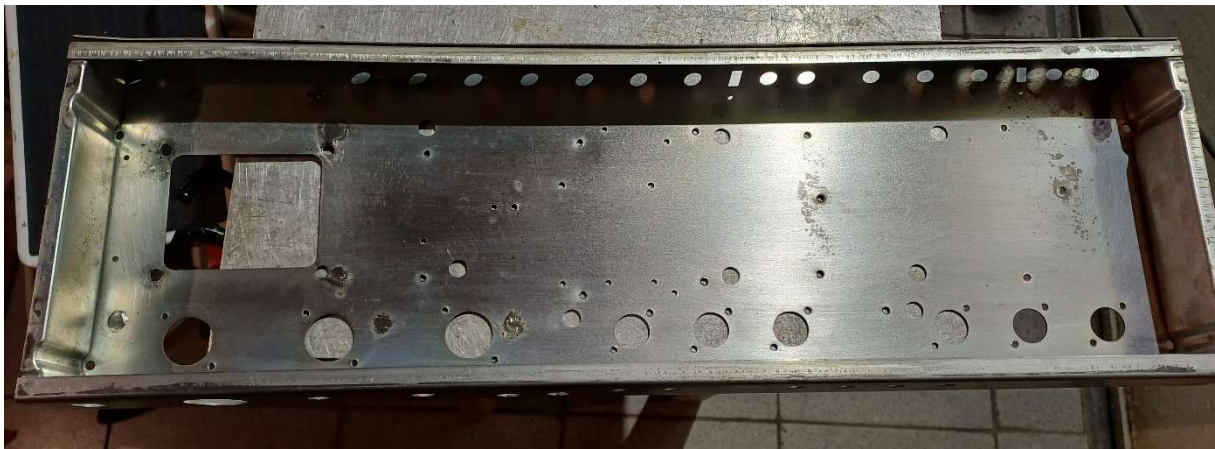
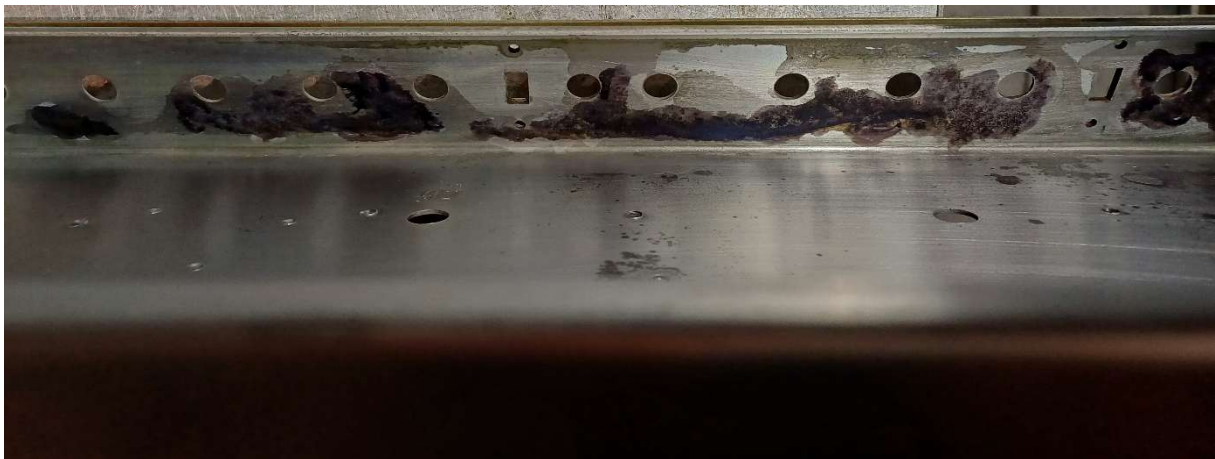
**Cleaning the chassis:**

I removed the rust and treated it. The rust-stop product does stain the metal, but it will sit behind the brass plate, so it's visually harmless anyway.

There was a lot of dirt on the inside and outside of the chassis (mostly tar from cigarette smoke, I guess). I managed to clean it all off with naphtha and a sponge.

The chassis was also bent in one place near the power transformer. It was easily bent back straight.

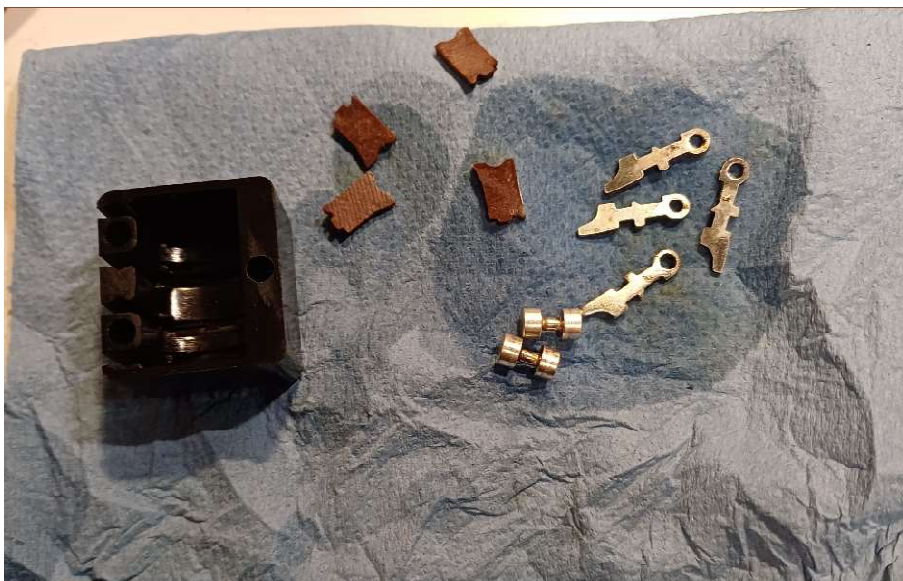
In the process of assembling I cleaned all the pots, cleaned all the valve sockets with IPA, cleaned the bright switches and jack sockets and knobs. I took apart the mains and standby switches and cleaned the contacts. All too often these switches, especially the mains switch, suffer from corrosion, which then causes poor continuity and arcing. In some switches entire chunks of metal are missing from the contacts, by the welding action of electrical arcs. In this case the switch was still ok:

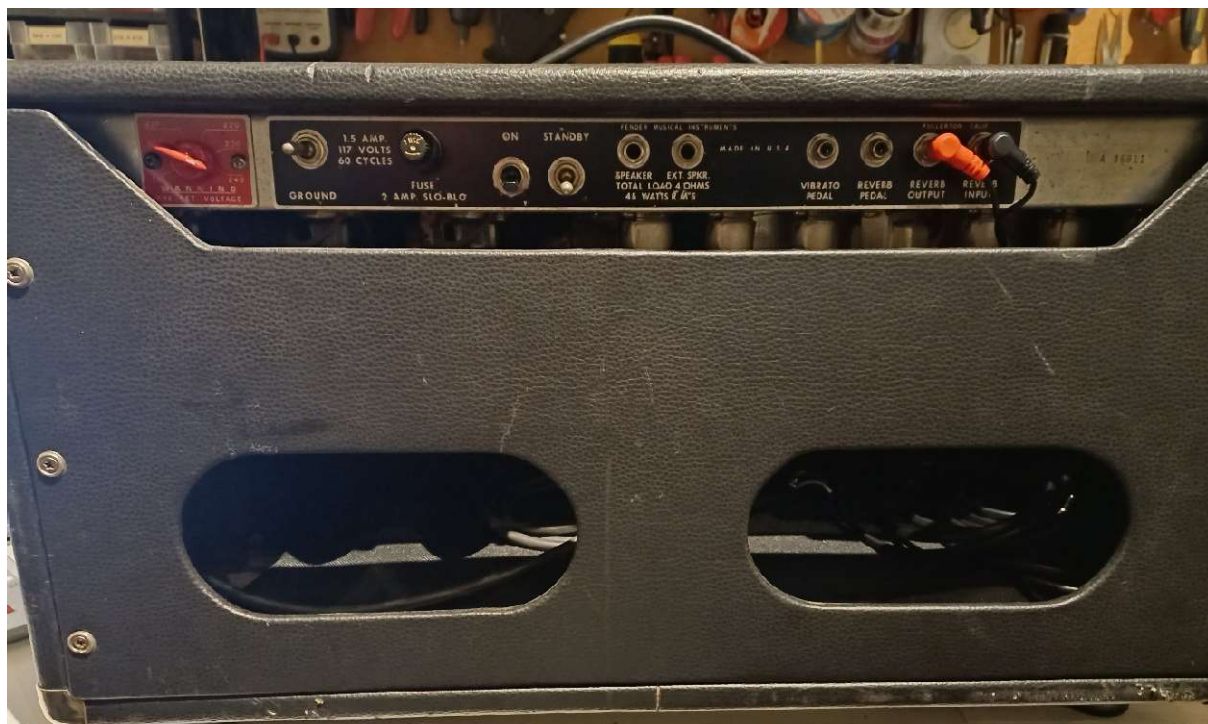
The amp is now biased correctly and sounds excellent. All voltages checked, all connections checked and firm, very low noise. It took about a whole week's work to complete the job.
